GAZOS CREEK WATERSHED ASSESSMENT AND ENHANCEMENT PLAN

APRIL 2003

Maya T. Conrad, Project Manager
Coastal Watershed Council
P.O. Box 1459
Santa Cruz, CA 95060
www.coastal-watershed.org
office@coastalws.org

Shawn Chartrand, Project Manager
Jonathan Owens, Hydrologist/Geomorphologist
Balance Hydrologics
841 Folger Avenue
Berkeley, CA 94710
www.balancehydro.com

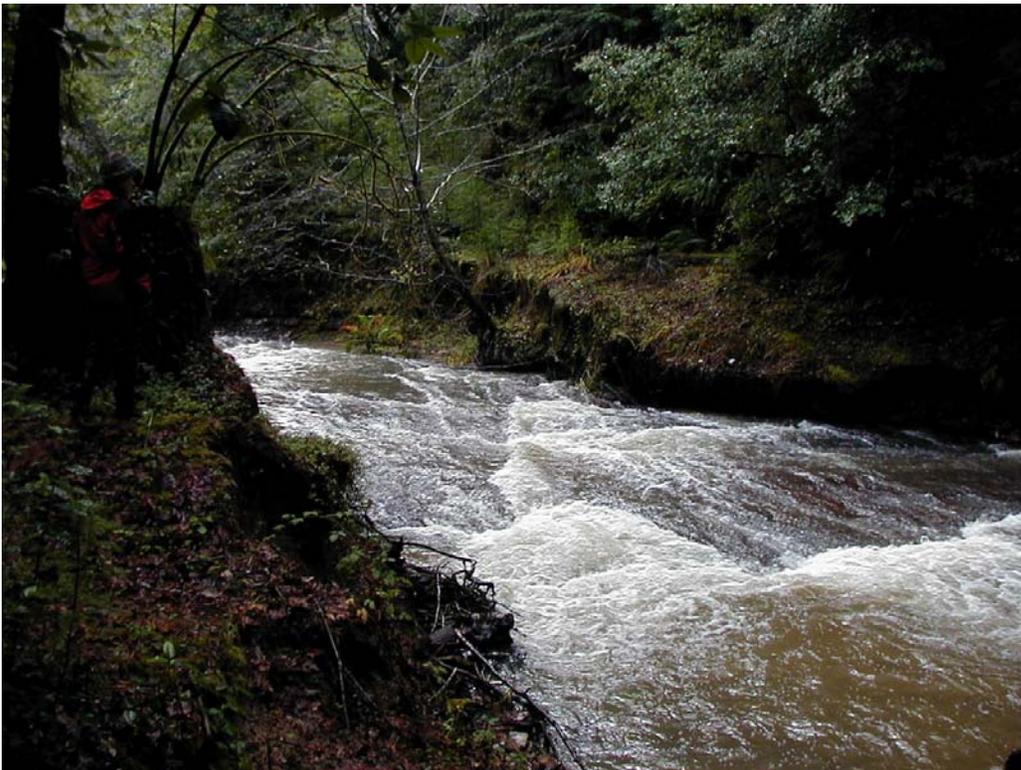
Description: Increase number of pot holes (a.k.a. ink wells) present at bedrock chutes; model new pot holes on existing pot-hole dimensions.

Purpose: To make upstream fish passage easier. The bedrock chutes are currently difficult, but not impossible, for fish to pass up them.
