San Francisquito Watershed Council

Adult Steelhead Passage in the Bear Creek Watershed

Jerry J. Smith, Dept. of Biological Sciences,
and Deborah R. Harden, Dept. of Geology,
San Jose State University, San Jose, CA 95192

Pat Showalter, Watershed Council Director *July 2001*

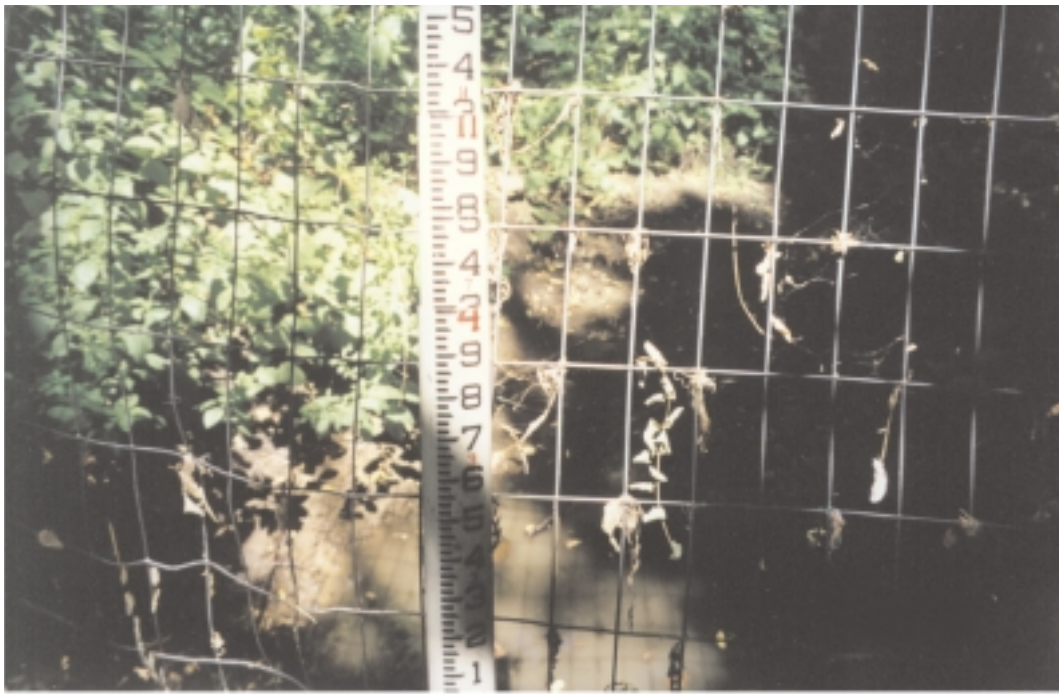
Stream	**West Union Creek**
Barrier Number	**19**
Location	150 feet upstream of Kings Mountain Road
Type of Barrier	Flashboard dam abutment

Description Old 25-foot wide flashboard dam abutment, with 14.8-foot center notch. No longer in use. Streambed upstream is 1 foot lower than top of 2-foot thick sill. The height of the drop from the sill is 3.9-feet to a large downstream pool over 5.4-feet deep.

Diagnosis The depth of the jump pool is sufficient to allow large steelhead to make the jump under most winter conditions. Smaller adult steelhead may have difficulty with the height of the jump.

Recommended Action Cutting a notch 3-feet wide and 0.5-1.0-feet deep in the sill would reduce the jump height to 2.9-3.4-feet and improve passage conditions for smaller adult steelhead.
